EVERDURE CALTITE SYSTEM

HYDROPHOBIC, PORE BLOCKING INGREDIENT (FOR)
MOISTURE IMPERVIOUS, CORROSION-FREE CONCRETE

PROJECT: *Seamless, Joint-free Acid Proof Concrete Floor, Seven Hills, N.S.W.*
CLIENT: *HARDMAN AUSTRALIA – Hydrochloric Acid production facility.*

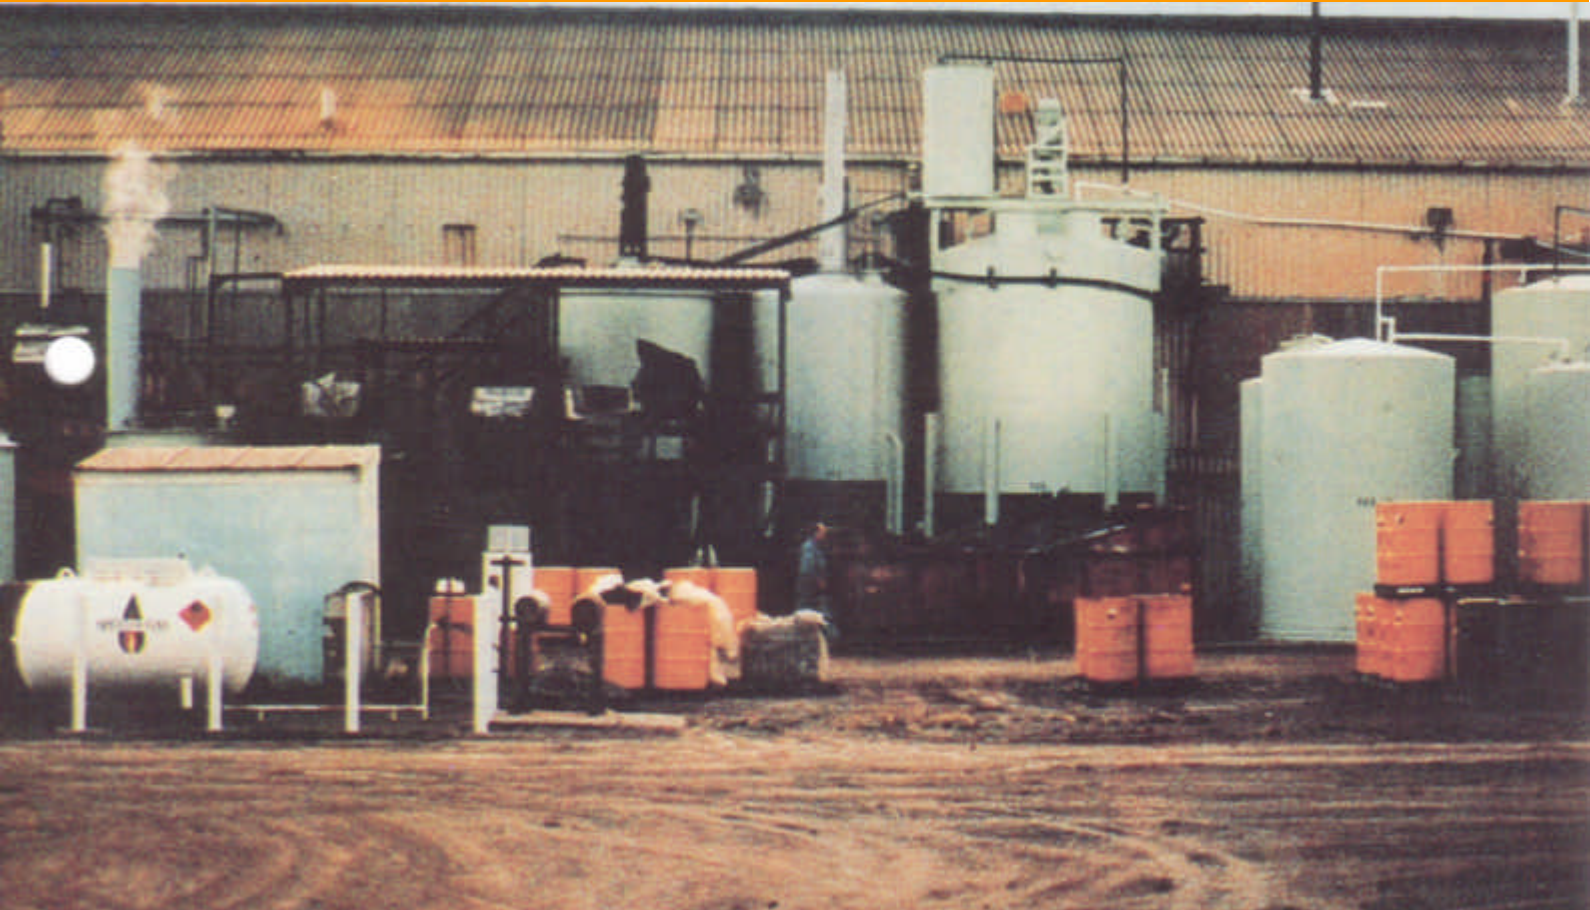
In 1990, after 20 years, when these photos were taken, the Everdure Caltite slab remains in service, with minor maintenance at 18 months age (see over). This outstanding service life directly enhancing the client firm's profitability and reputation, by eliminating replacement, down time and lost production, over this very long period. Under these service conditions, Everdure Caltite System has increased durability and service life by more than 40 times over unmodified concrete.

Prior to 1970, daily exposure to 32% Hydrochloric Acid, as well as hot Zinc Chloride solutions, had reduced several previous, outdoor 6 inch (150mm) slabs to "rubble", in as many months. That is a rate of disintegration of 1" (25mm) per month!

In 1970, a new, seamless, joint-free replacement slab was cast (150mm thick) using Everdure Caltite System ingredients. The surface was not initially protected by a suitable coating to prevent surface etching, as Cementaid now normally recommend under such severe exposure conditions.

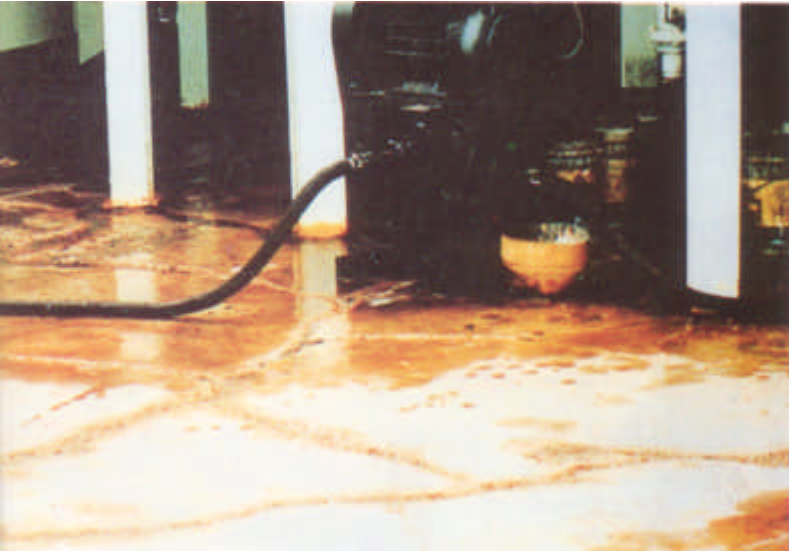
Owing to the disappointing performance of previous surface / epoxy coatings on ordinary concrete in earlier, failed floors, the client determined that the new Caltite concrete surface should be left (initially) unprotected. While moisture/acid solutes cannot penetrate Everdure Caltite concrete to any significant depth, the extreme surface is still "in contact". Thus, after 18 months, the surface 20-25mm (1") had been slowly eroded by constant acid "etching", compounded by everyday wheeled and forklift traffic. That rate is 1" per 18 months, compared to 1" per month for the plain slab! Already an 18 fold improvement in service life.

Coring proved the slab itself remained structurally sound, with compressive strengths of over 6,000 psi (40Mpa)

The etched surface was simply washed with caustic and reinstated in 1972 with a sand:cement Caltite screed (25-35 mm). This time, a 1mm epoxy coating was duly applied to protect the extreme surface of the Caltite Concrete. The floor remains in service in 2003.

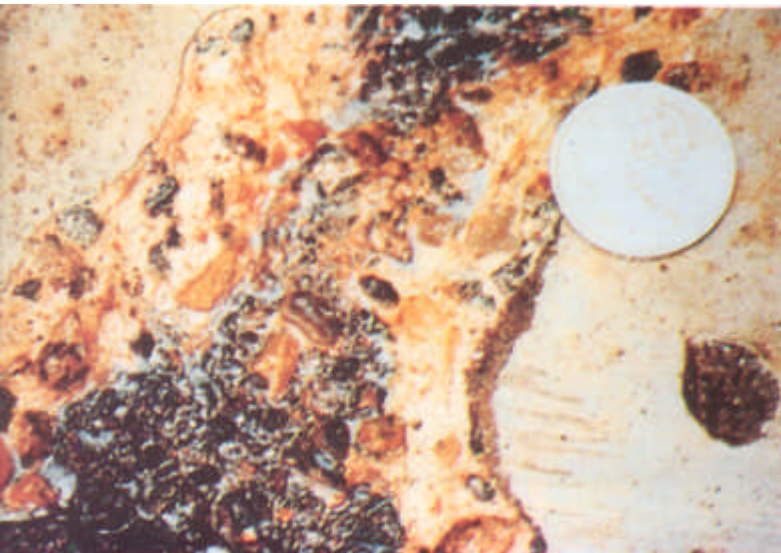
With constant traffic over the slab, the epoxy coating was not able to bridge micro-cracks which appeared early in the unreinforced screed. (Today's Everdure Caltite acid-proof floors/screeds may include specialised crack-control fibres). These photos show the effect of 20 years acid etching on the "faces" of these cracks, only mildly exacerbated by abrasion / impact from wheeled & forklift traffic.

It is essential to note that the epoxy coating remains tenaciously intact, right up to the edge of the break, without de-bonding or de-lamination, as otherwise occurs when normal, absorptive concrete is used.

The coin shown is equivalent in size to the UK 10 pence piece, just over a half inch across. This floor continues in service, and demonstrates again that Everdure Caltite System delivers the most durable, hard-wearing concrete available in the world today.
